# Assessment of Dam Safety Coal Combustion Surface Impoundments Draft Report

American Electric Power  
General James Gavin  
Power Plant  
Cheshire, Ohio

July 2, 2009

CHA Project No. 20085.4000.1510

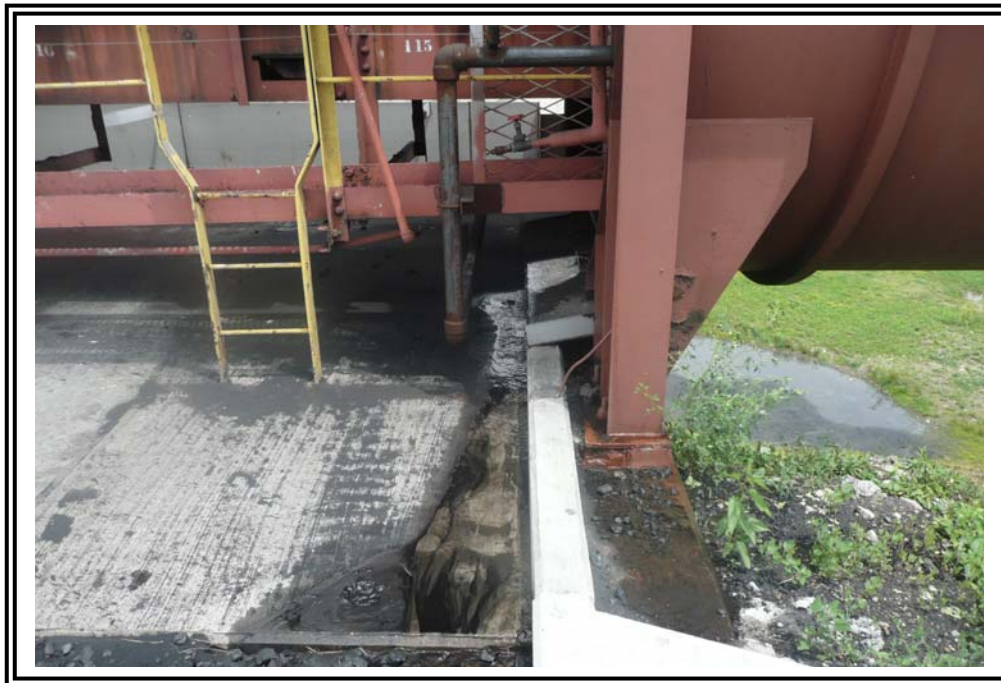
44

In 2008 a concrete pad and knee wall was placed under the coal conveyor at this location to minimize the impact of routine cleaning of the coal conveyor on the dike. The runoff now flows across the crest and drains to the pond.

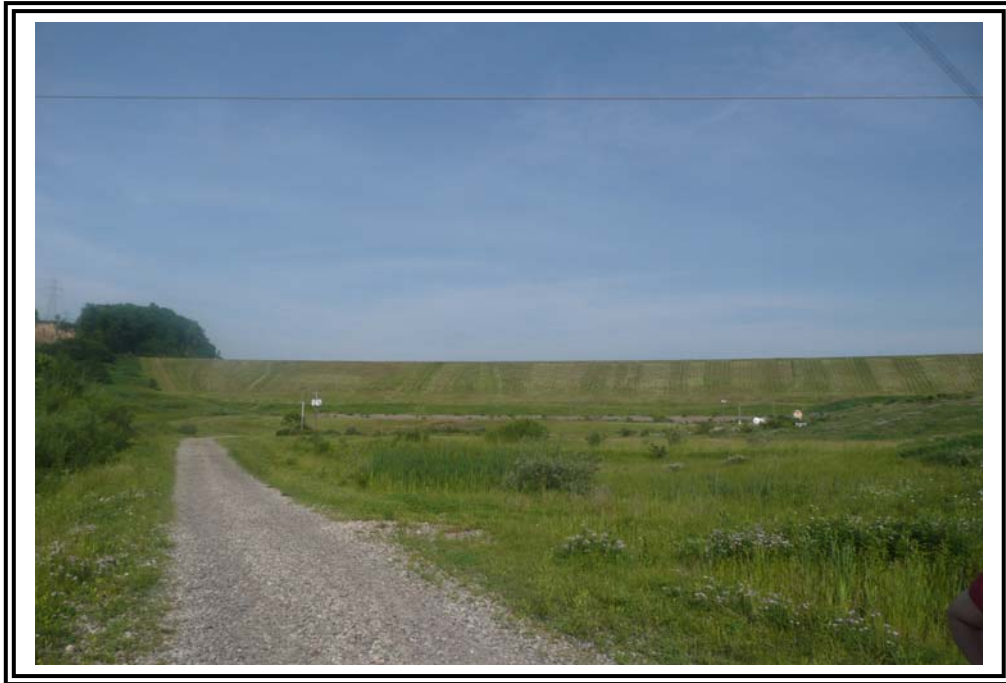
45

Right (south) side of Stingy Creek Dam as seen from downstream.

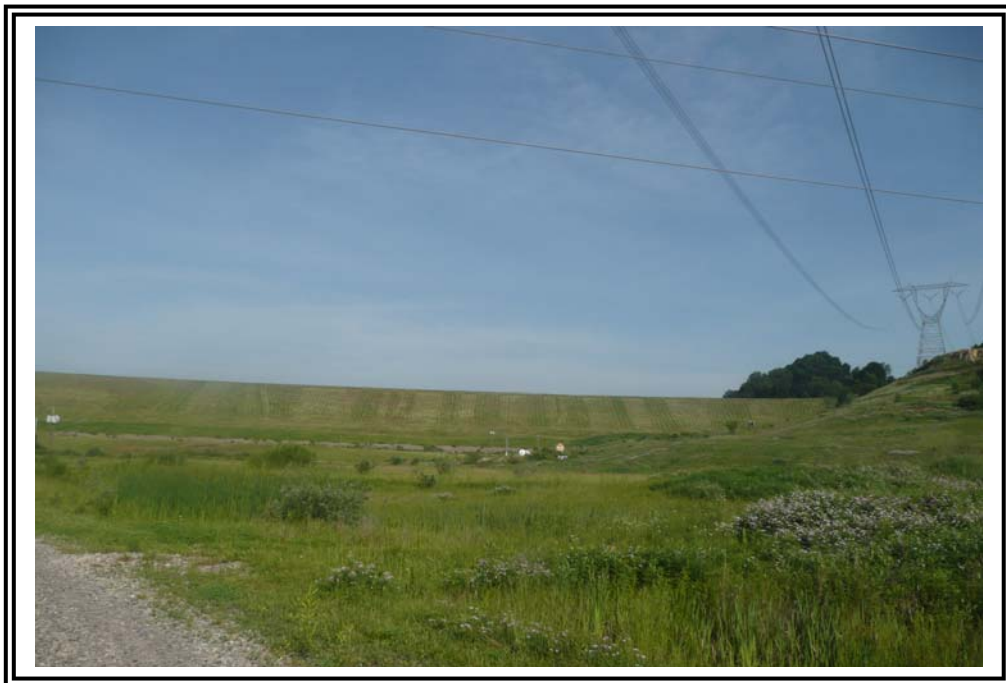
46

Left (north) side of Stingy Creek Dam as seen from downstream.

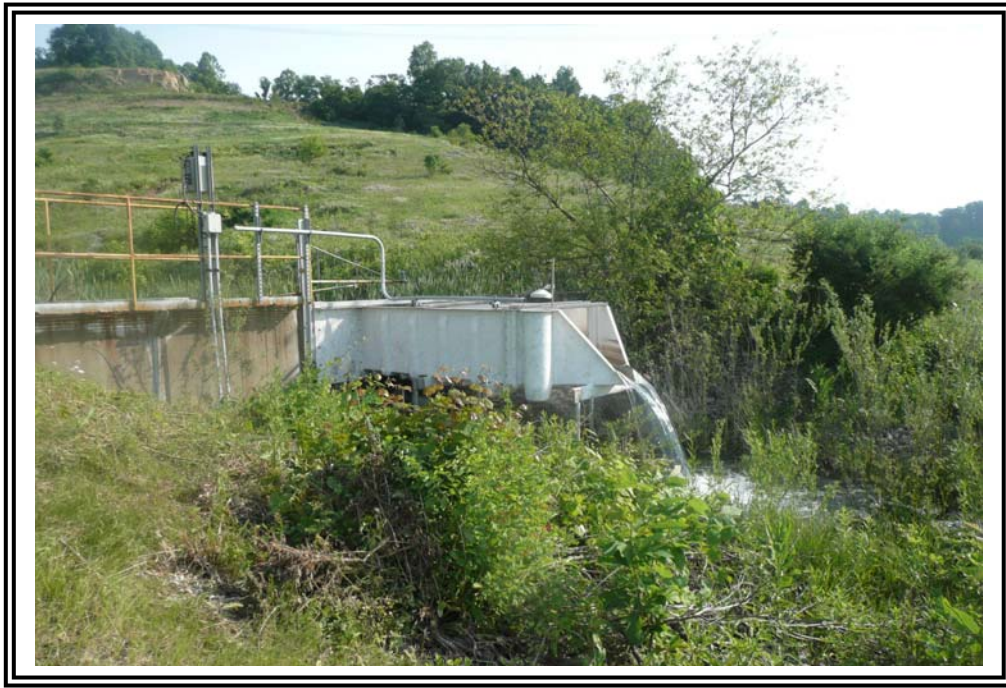
47

Outlet flow from the intake tower within the reservoir.

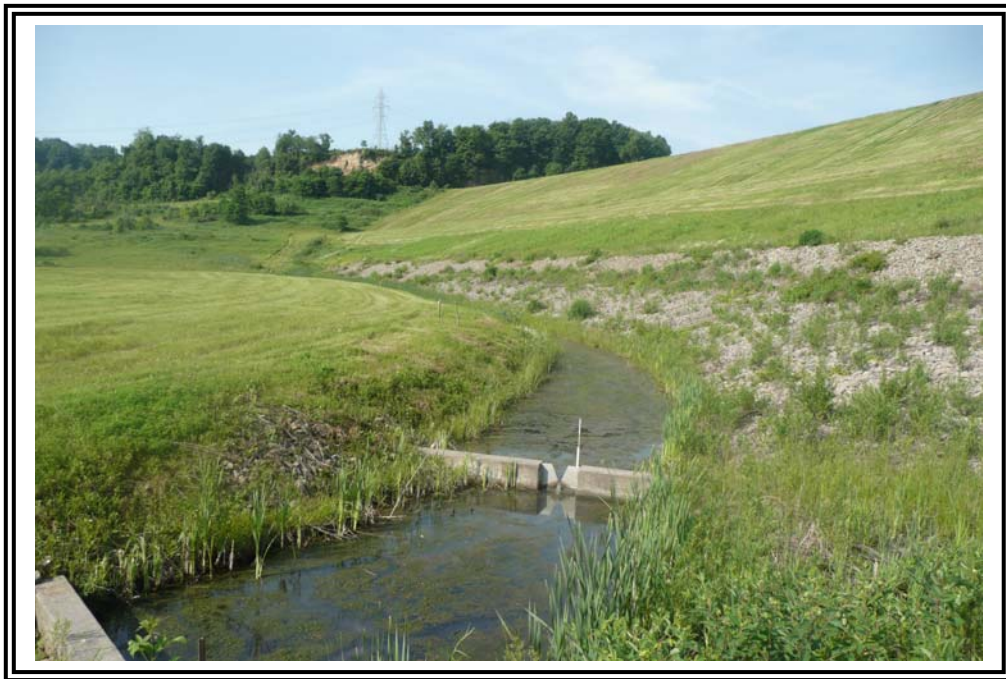
48

Drainage swale along toe of dam. Note monitoring weir structures. Much of the flow observed here was reportedly from recent rainfall runoff.

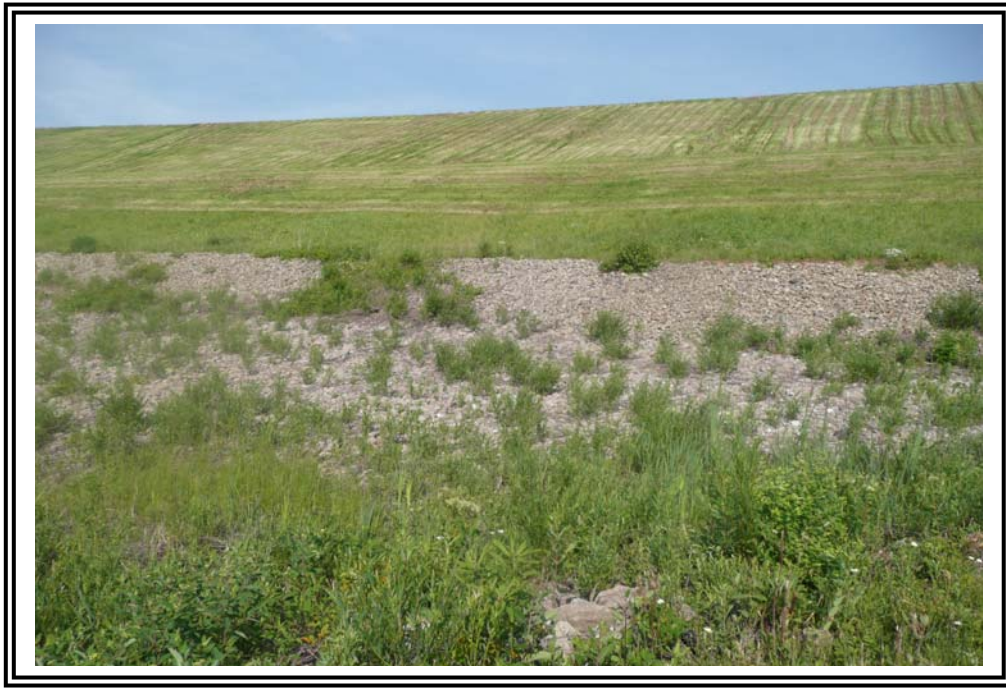
49

Toe drain covered with 6-inch diameter rip rap.

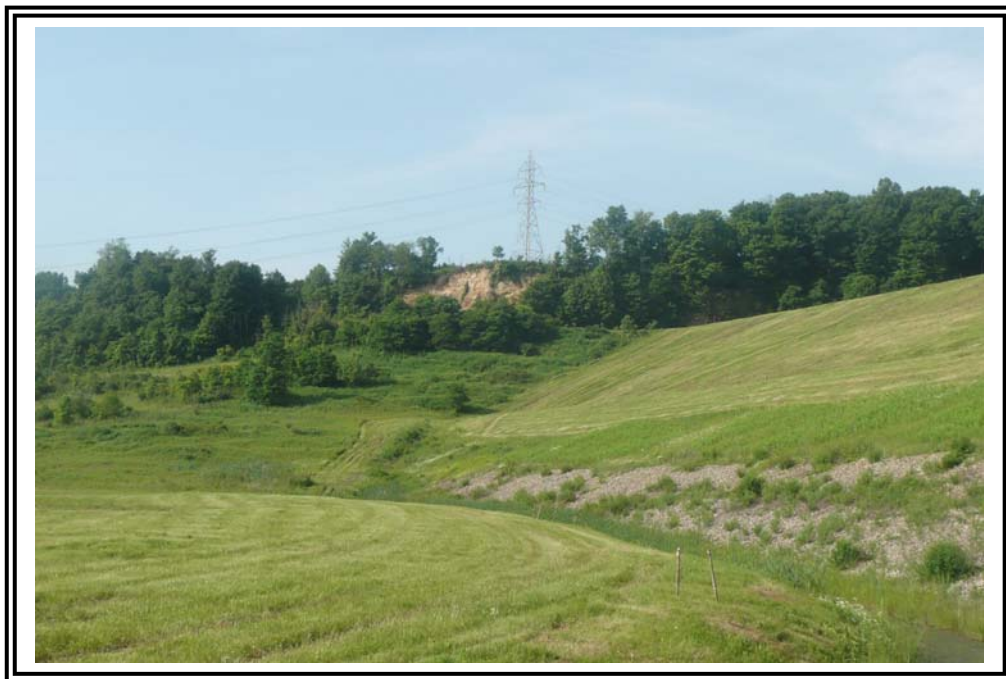
50

Right (south) downstream abutment contact.

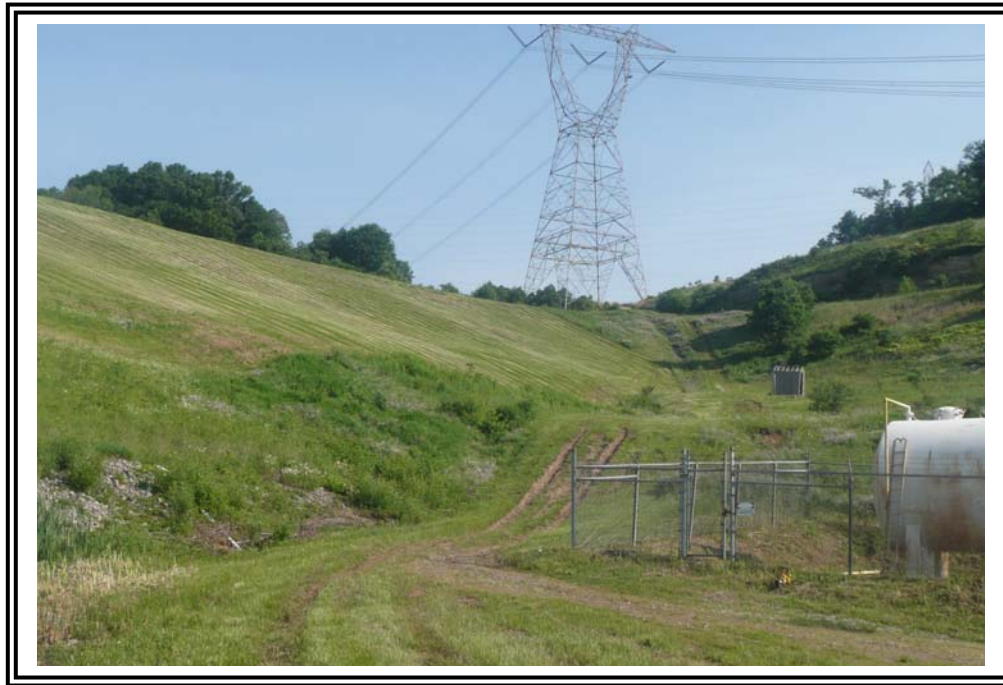
51

Left (north) downstream abutment contact.

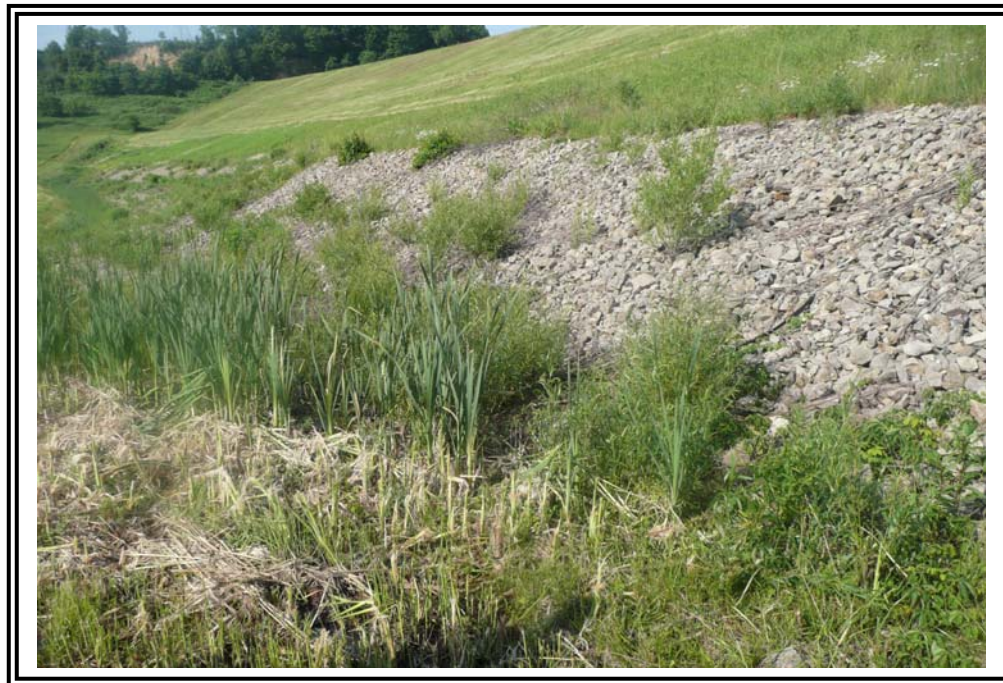
52

Toe drain area shows vegetative signs of being perennially wet.

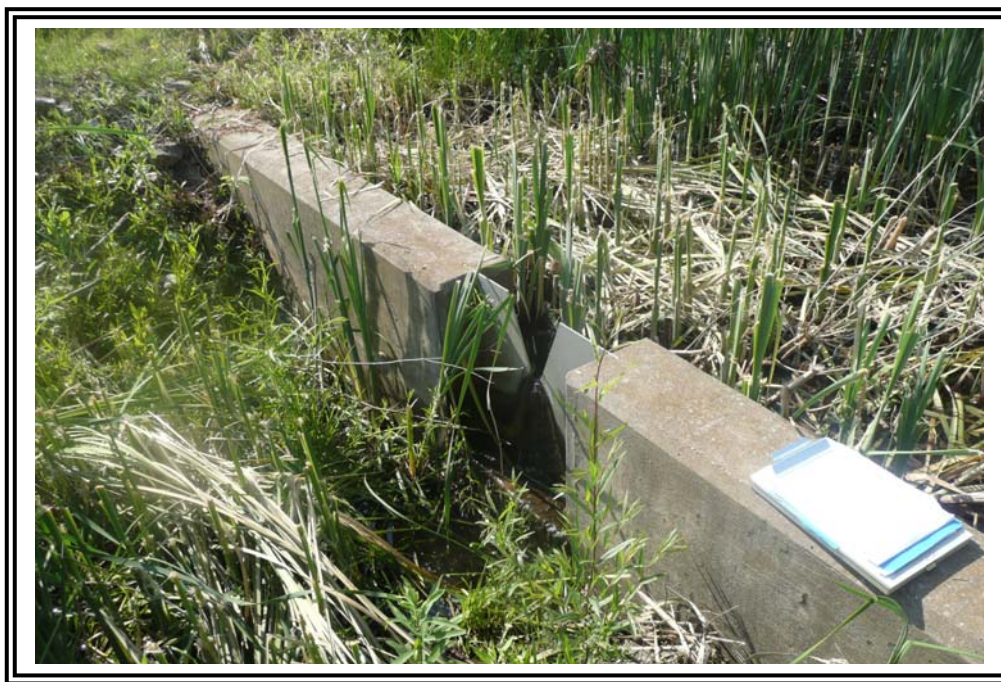
54

Close-up of Weir 3 near right (south) abutment/toe contact. Note significant difference in flow here compared to that shown in Photo (4) where all toe and groin flow for the whole length of the dam cumulates and discharges at Weir 1.

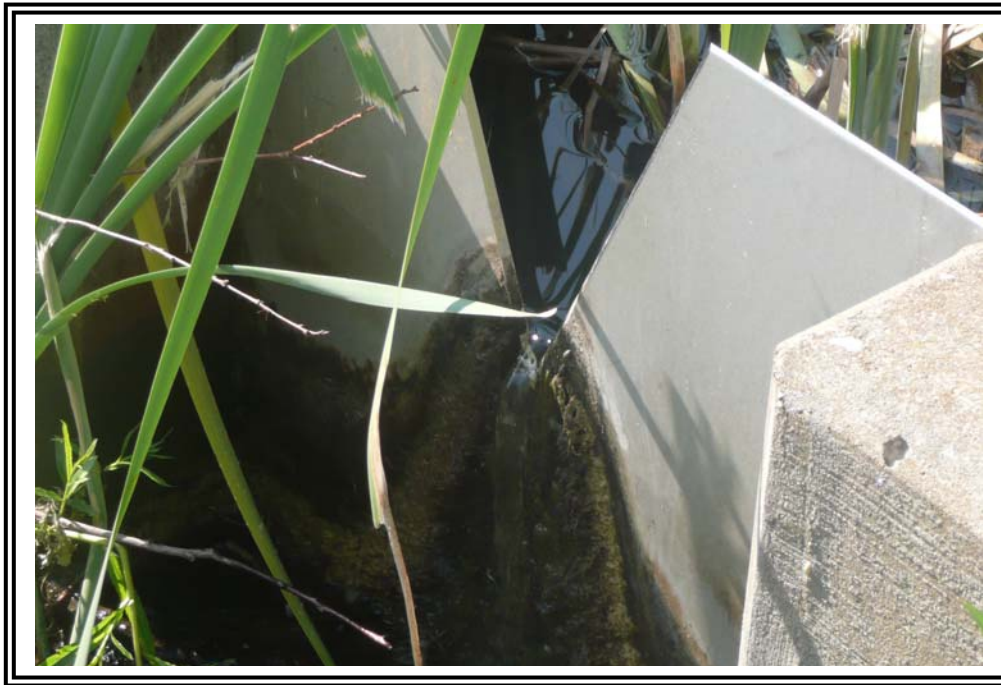
55

Close-up of Weir 3. Note the week prior to CHA's visit the site received approximately 2.9 inches of rain.

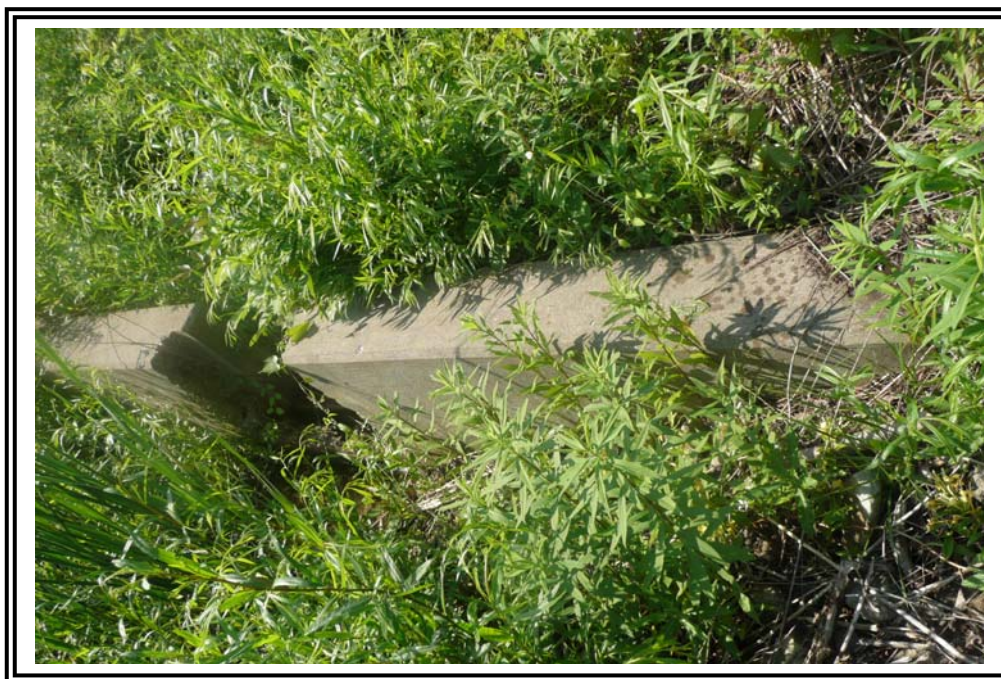
56

Abandoned weir structure located upstream of Weir 3 (appears weir plate was chipped out of the concrete). AEP staff was not aware when this was abandoned.

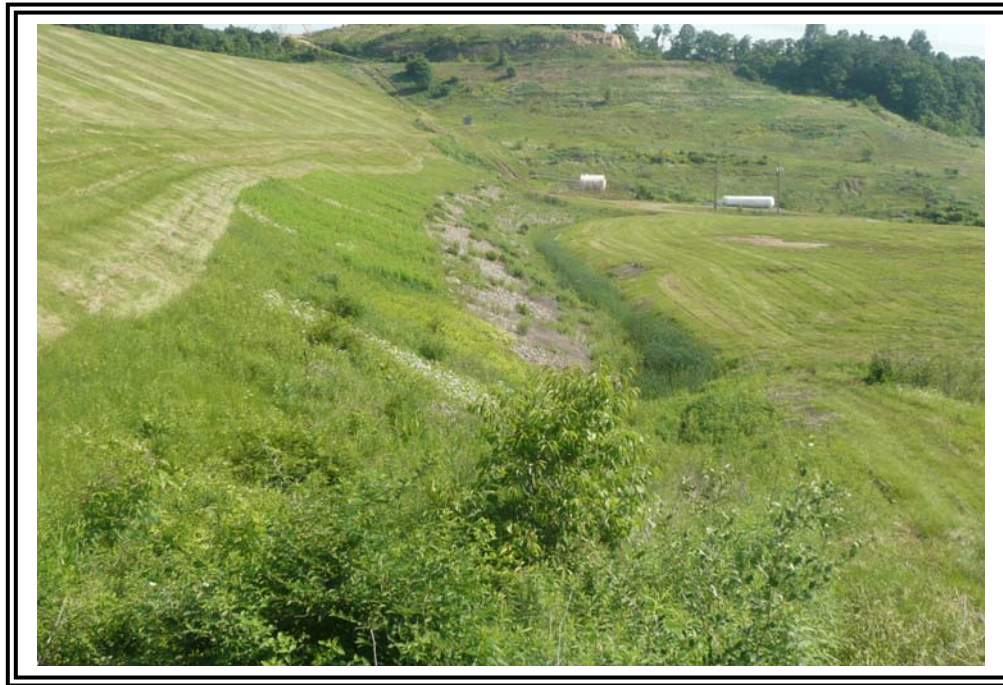
57

View of the dam toe looking north from the south abutment.

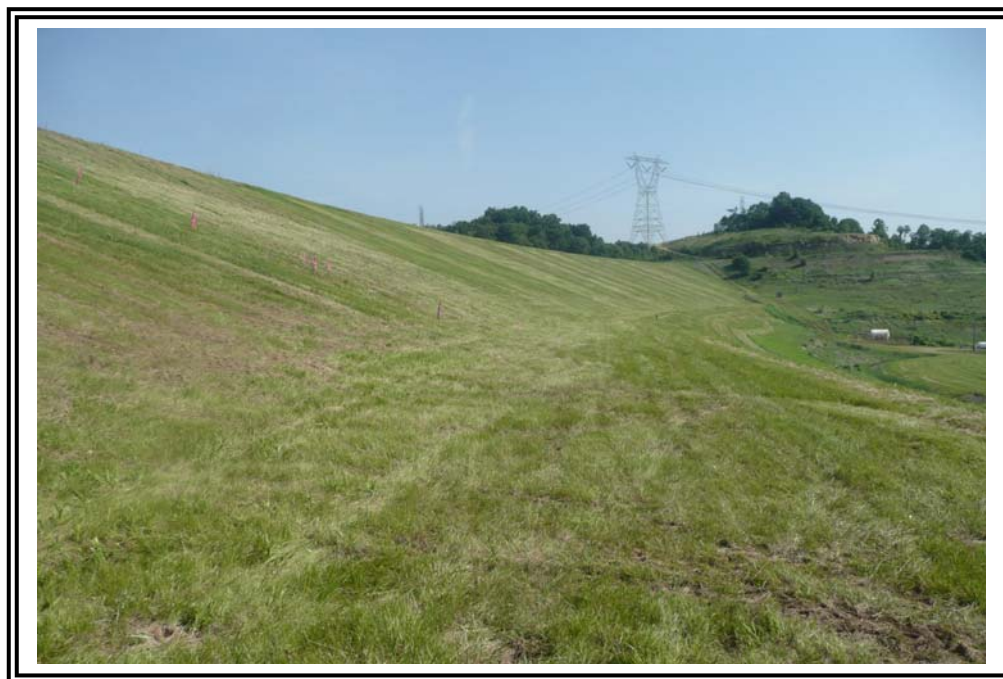
58

View along the bench on the downstream slope looking north.  
Note survey monitoring points, monitoring wells, and inclinometers.

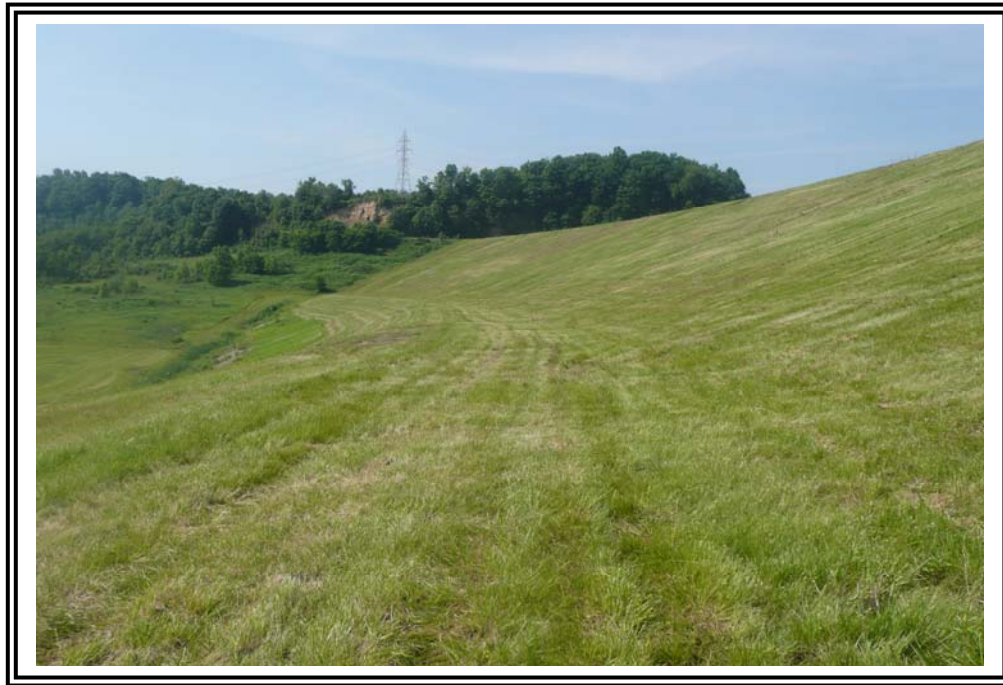
59

View along the bench on the downstream slope looking south.

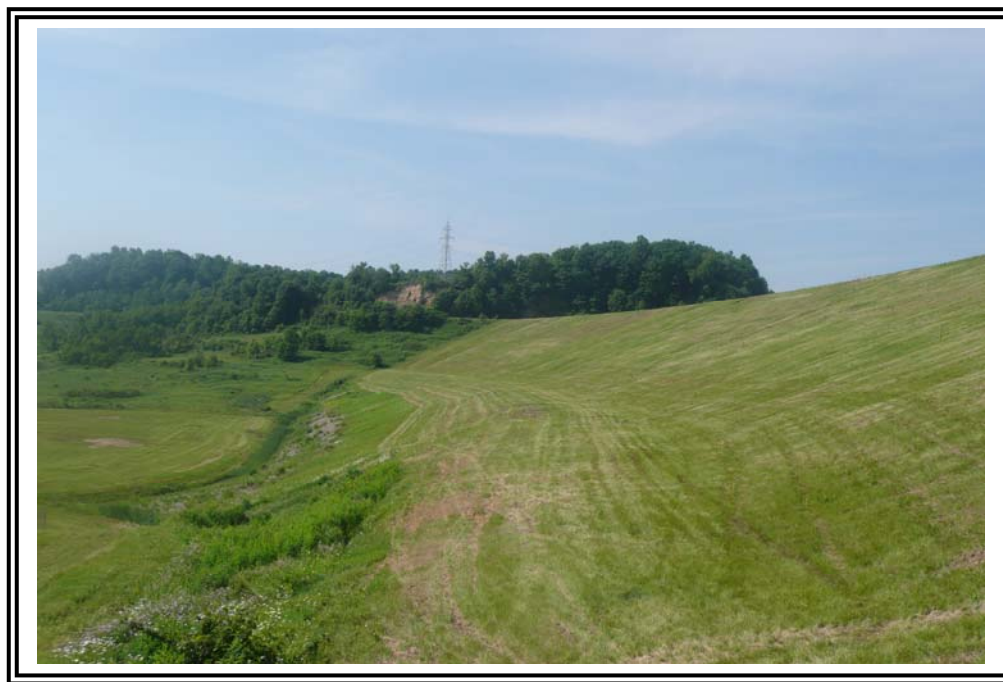
60

Downstream slope looking south (taken from north abutment).

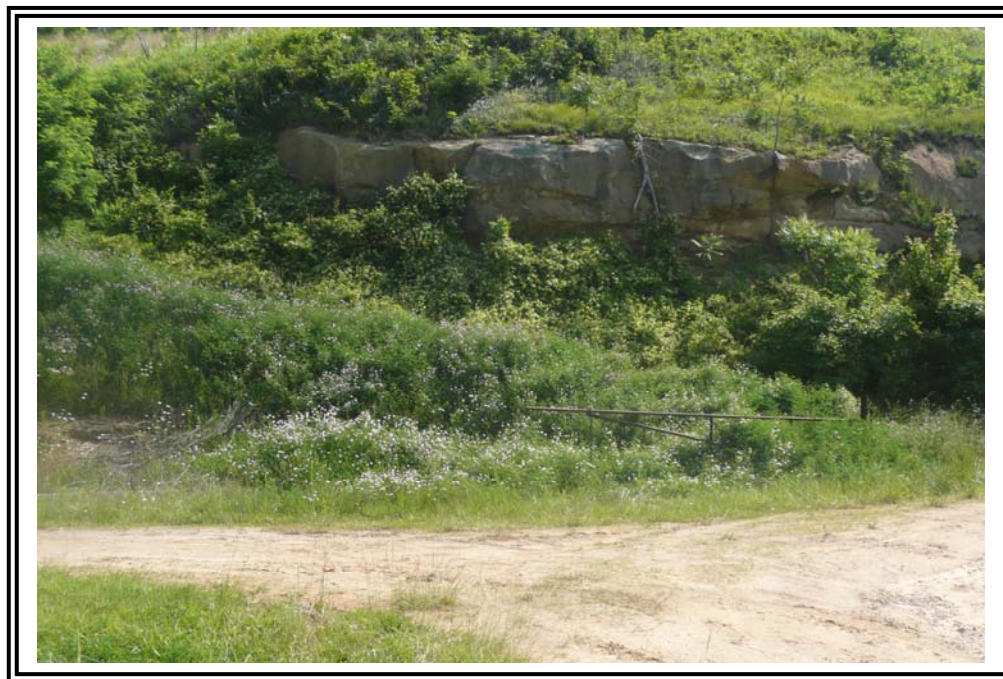
62

Left (north) abutment.

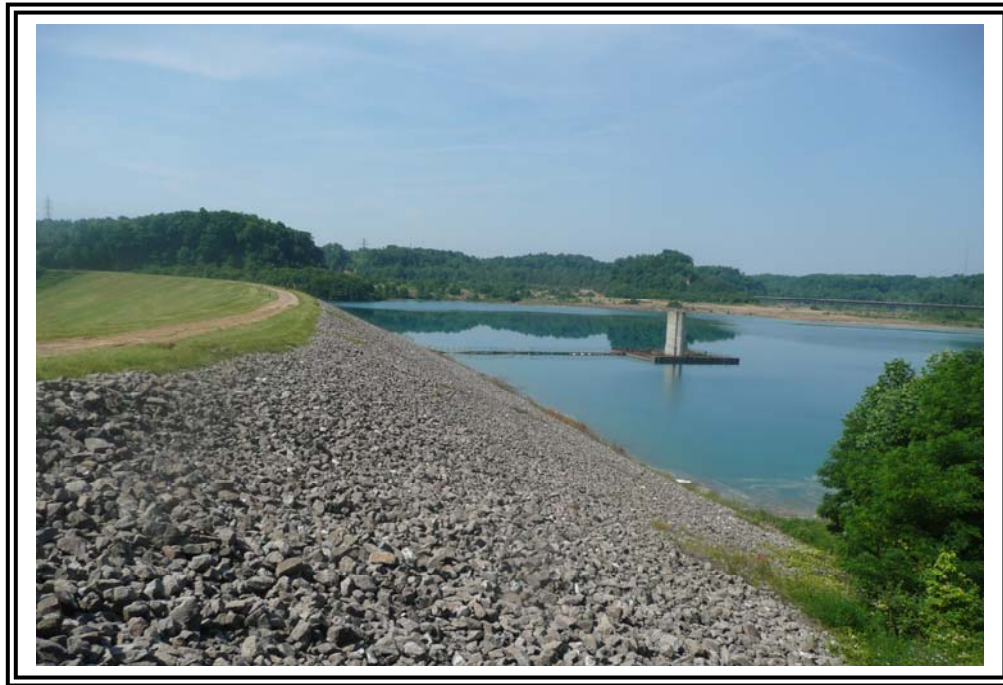
63

Upstream slope covered with 8-inch diameter rip rap.

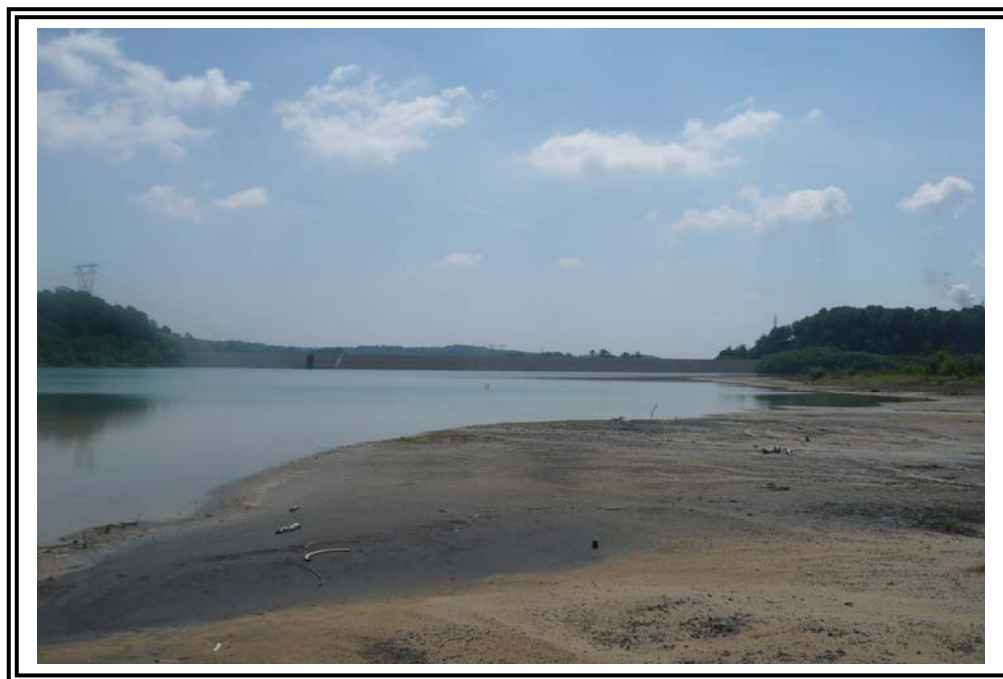
64

Upstream slope of the dam.

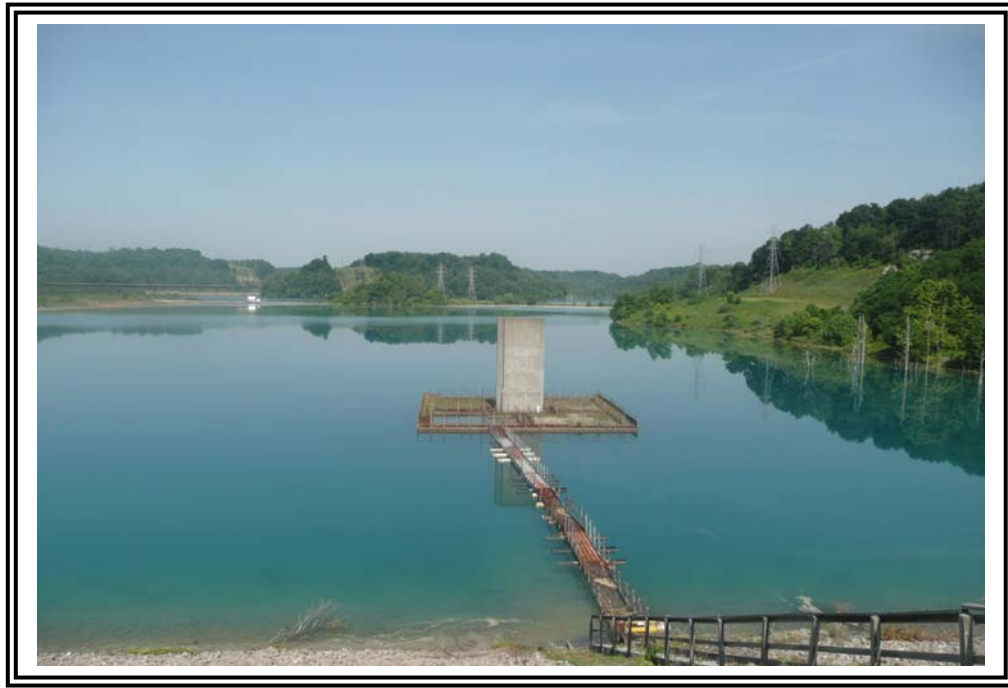
67

Intake tower from the dam crest (looking west).

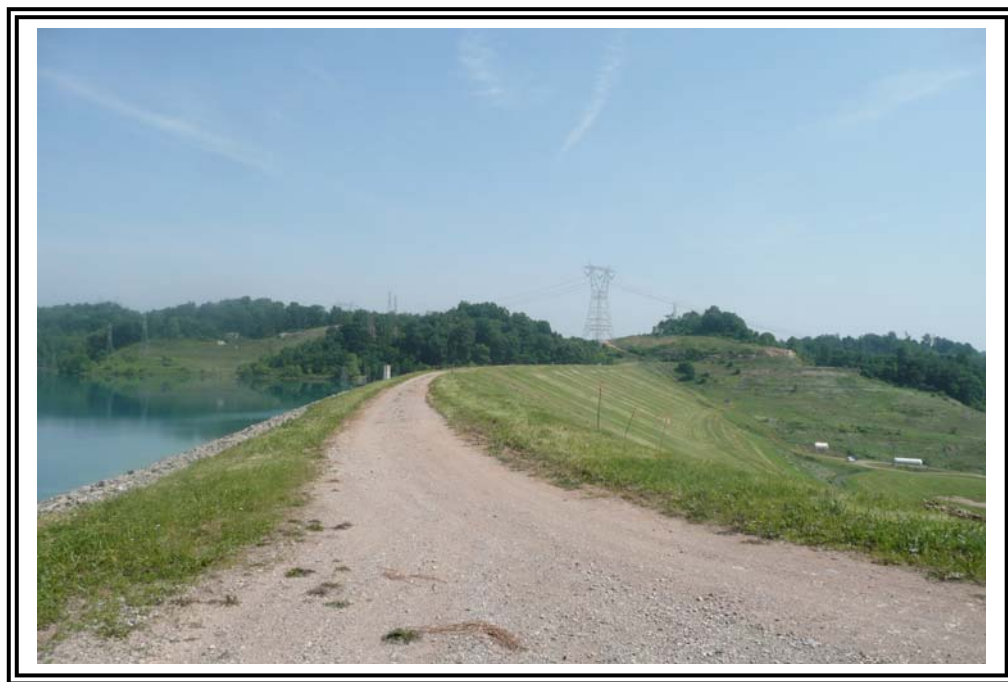
68

Dam crest and downstream slope from the right (south) abutment looking north.

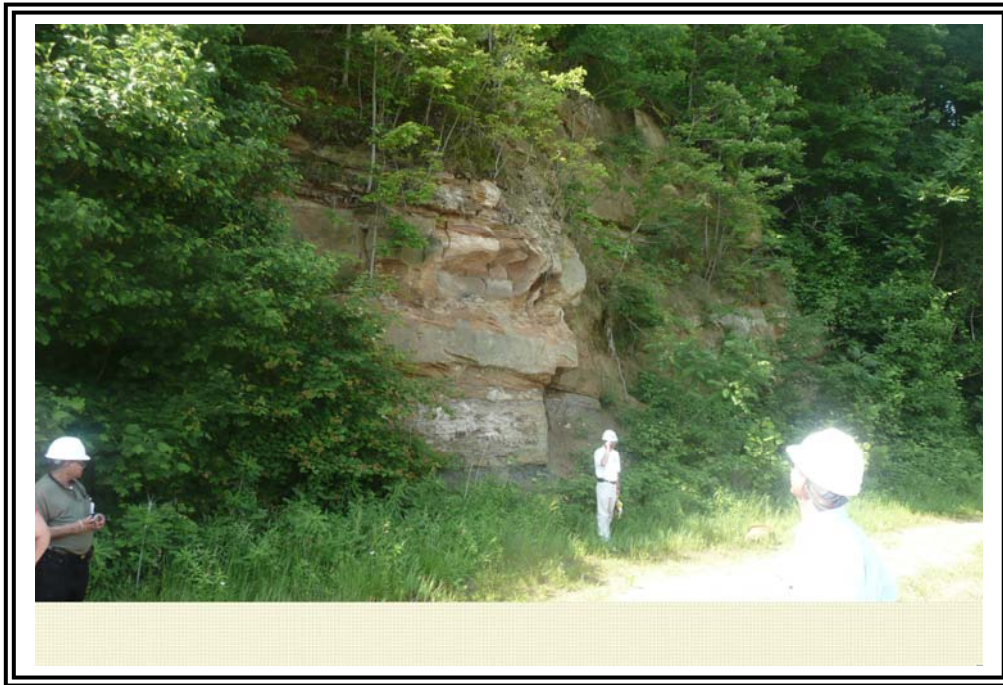
69

Right (south) abutment.

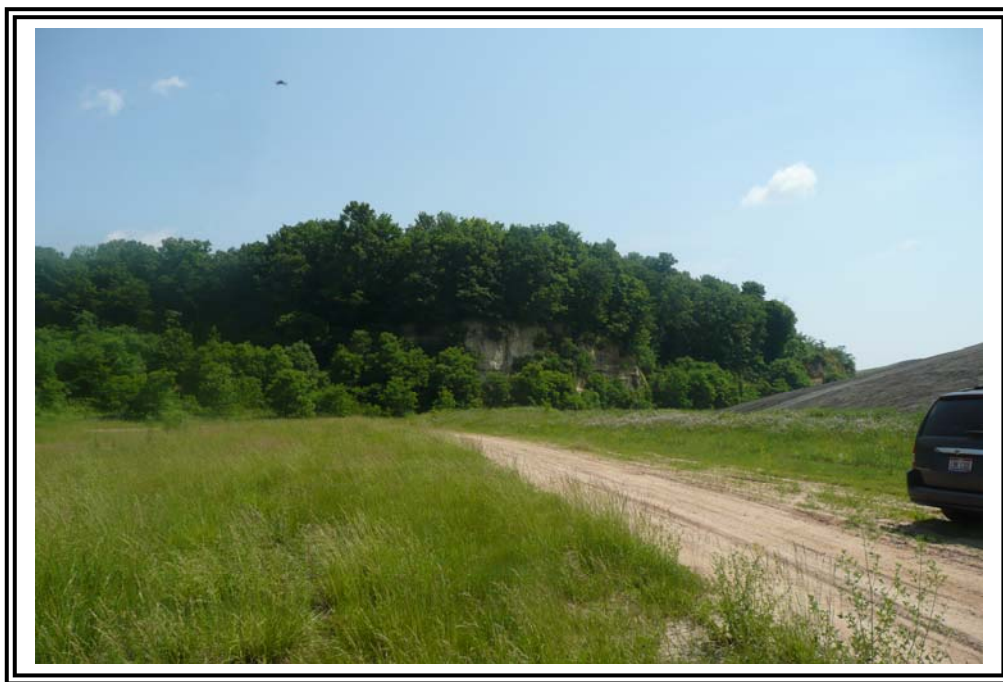
70

Left abutment of abandoned emergency spillway. Note landfill in right of photo.

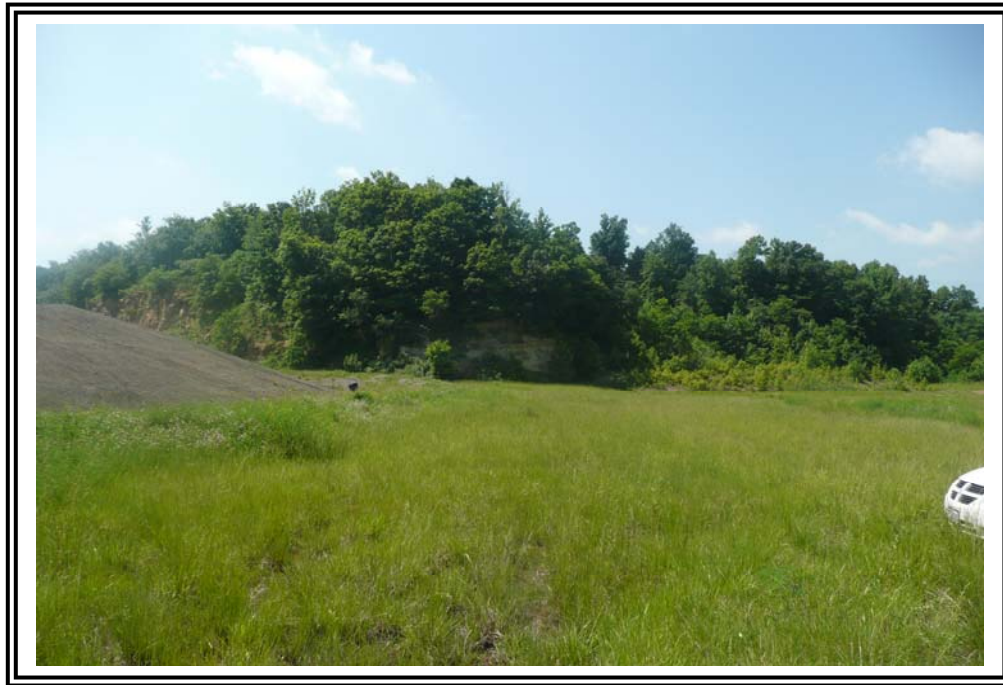
71

Right abutment of abandoned emergency spillway. Note landfill in left of photo.

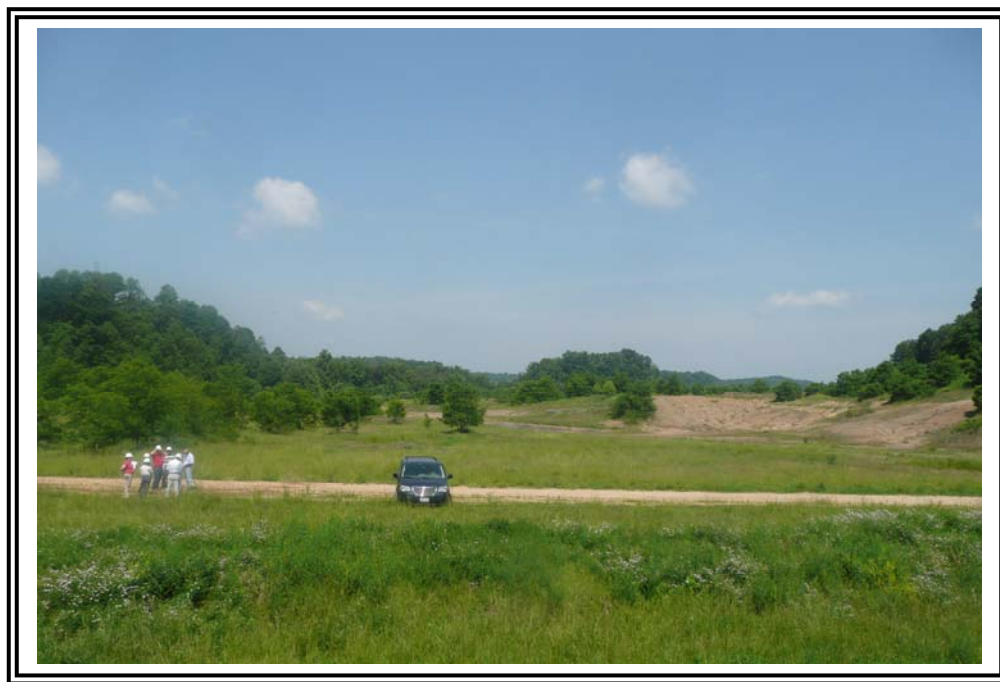
72

Abandoned emergency spillway looking toward reservoir.
